Peace of Mind Automotive Inspection Report.

Score	75%	Flagged items	1	Actions	0
Customer name					Greg
Date / Time					Aug 3rd
Payment method					Invoice
Inspection cost					249
Vehicle Year / Make / Model / Color					1979 Cadillac deville coupe
VIN					6d47s9c386862
license plate					Dealer temp
Mileage					14700 on odo
Color					Seafoam green

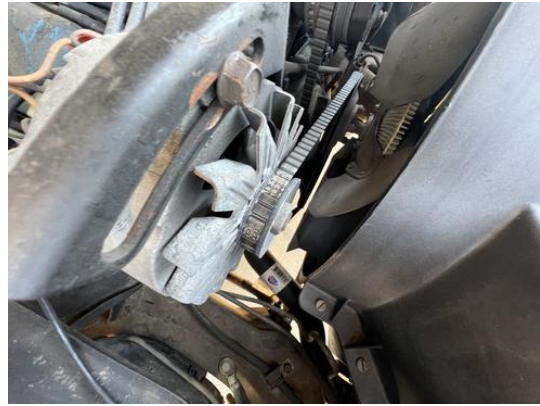
Photo 116

Engine clean internally, no gunk or sludge present. Proper signs of maintenance present. All external engine accessories in good working order. External drive belt and healthy condition. No external oil leaks or seepage from engine. Coolant make sure correct and coolant system functionality healthy.

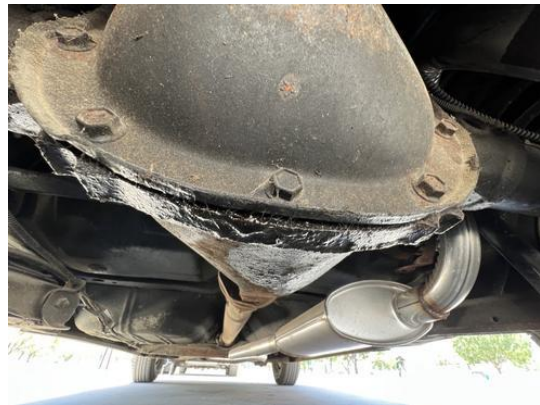
Photo 138

</div> <div> Photo 130 Photo 131 Photo 132 Photo 133 Photo 134 Photo 135 </div>	
Transmission cooler / lines	Healthy
Front differential condition	N/A
Center differential condition	N/A
Rear differential condition	Healthy
Residue noticed around rear differential cover, cover may need to be resealed in the future	
<div>
