## Peace of Mind Automotive Inspection Report.

Score	<b>100%</b>	Flagged items	<b>0</b>	Actions	<b>0</b>
<b>Site conducted</b>					Unanswered
<b>Customer name</b>					Jim
<b>Date / Time</b>					Sep 17th
<b>Payment method</b>					Invoice
<b>Inspection cost</b>					169
<b>Vehicle Year / Make / Model / Color</b>					2013 Jeep Wrangler red
<b>VIN</b>					72473 last 5
<b>license plate</b>					Dealer
<b>Mileage</b>					98343
<b>Color</b>					Red

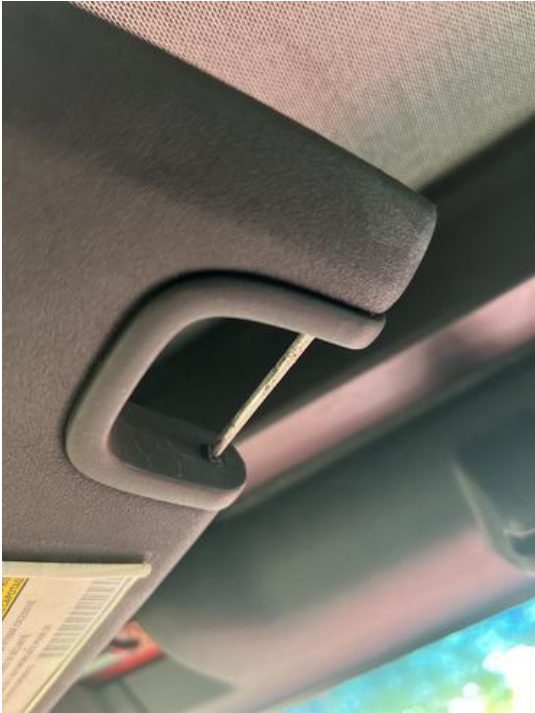
Photo 1

Call driver and passenger sunvisors are missing the plastic grommet that locks them into place

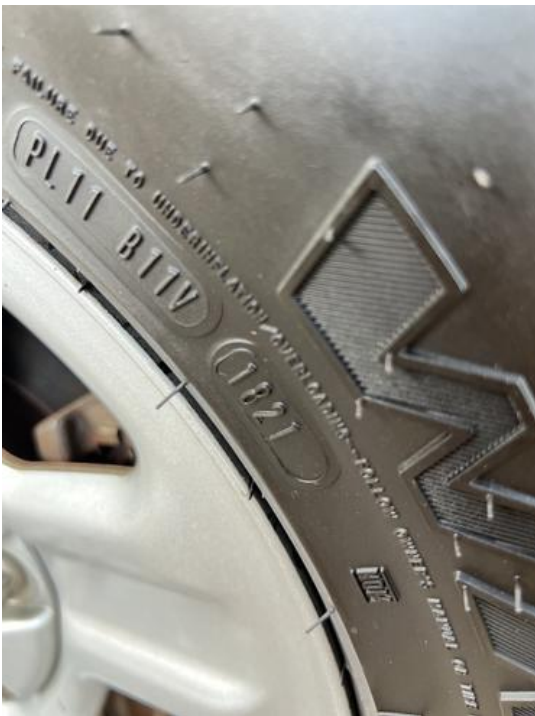
Photo 61

Tires are matching on all four corners with over 85% tread life remaining. No abnormal wear present whatsoever

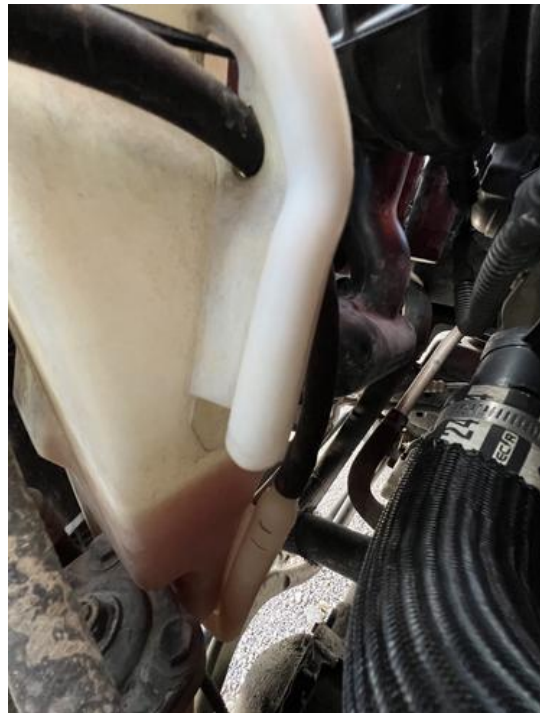
Photo 70

Engine clean internally, no gunk or sludge present. Proper signs of maintenance present. All external engine accessories in good working order. External drive belt in healthy condition. Coolant mixture correct and coolant system functionality healthy. No external oil leaks or seepage from anywhere on the engine, noticed previous replacement of both primary and secondary oil pan gasket. Currently no mechanical issues present in relation to the engine.

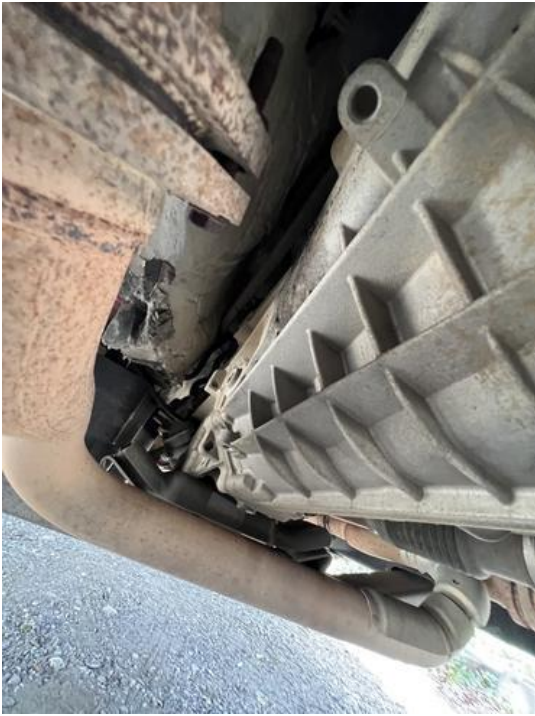
Photo 83

No transmission fluid leak out. No fluid leak out from the center differential, front differential or rear differential casing.

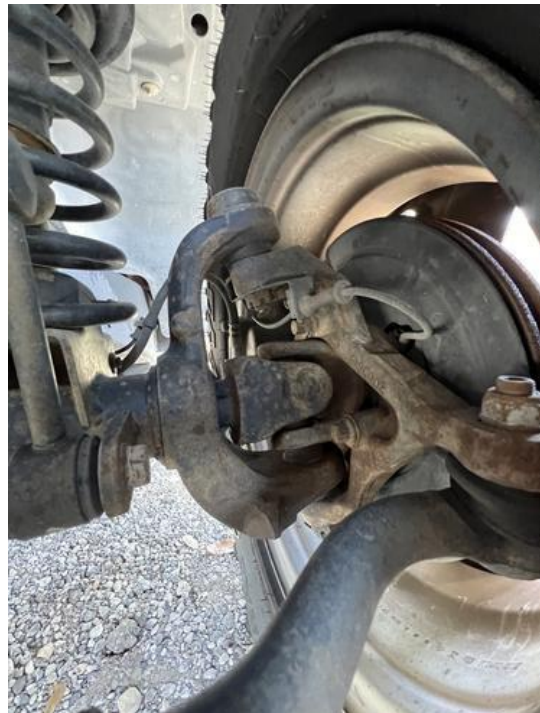
Photo 96

Normal wear/fatigue notice to suspension. No suspension components are blown out and do for replacement however nothing is recognized as recently replaced either. No excessive surface rust on the expose metal. All rubber in relation to mounts joints and bushings rich with texture.
