Peace of Mind Automotive Inspection Report.

Score	75%	Flagged items	1	Actions	0
Customer name					Greg
Date / Time					Aug 3rd
Payment method					Invoice
Inspection cost					249
Vehicle Year / Make / Model / Color					1979 Cadillac deville coupe
VIN					6d47s9c386862
license plate					Dealer temp
Mileage					14700 on odo
Color					Seafoam green

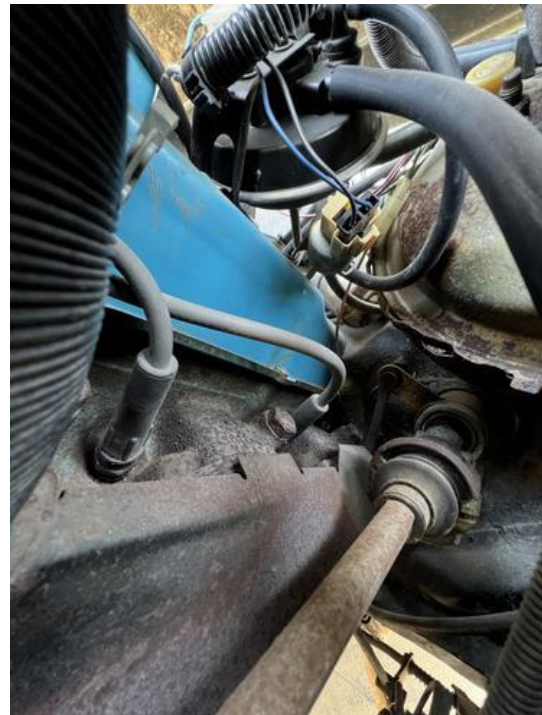
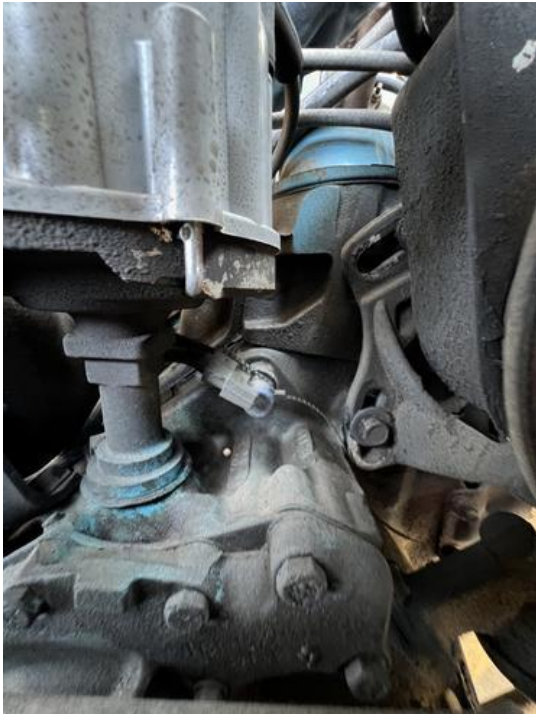
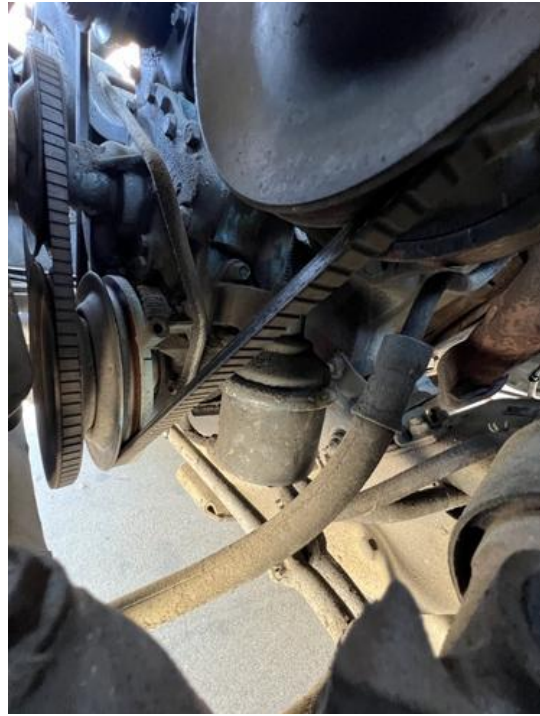
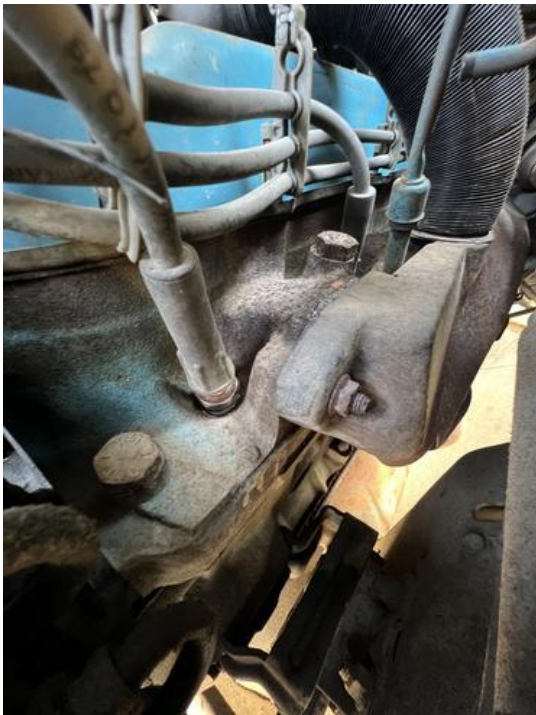
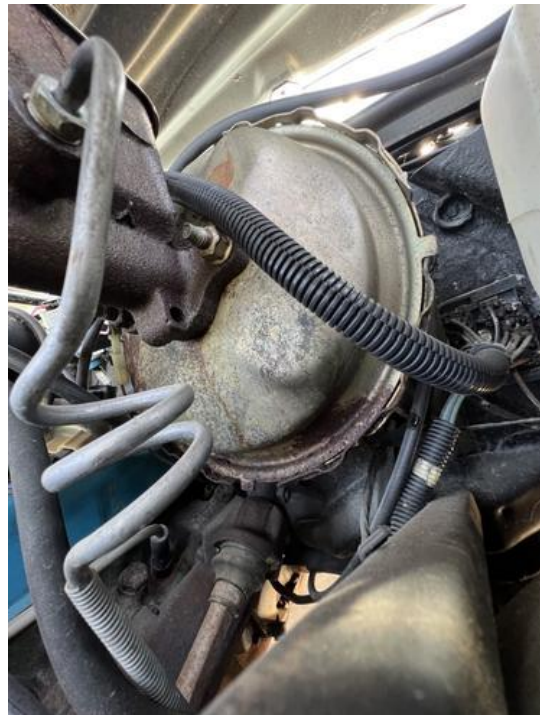
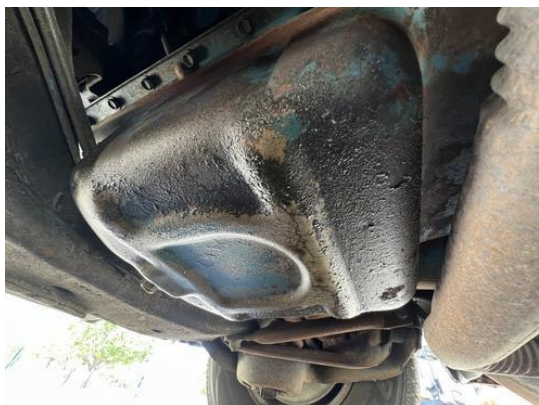
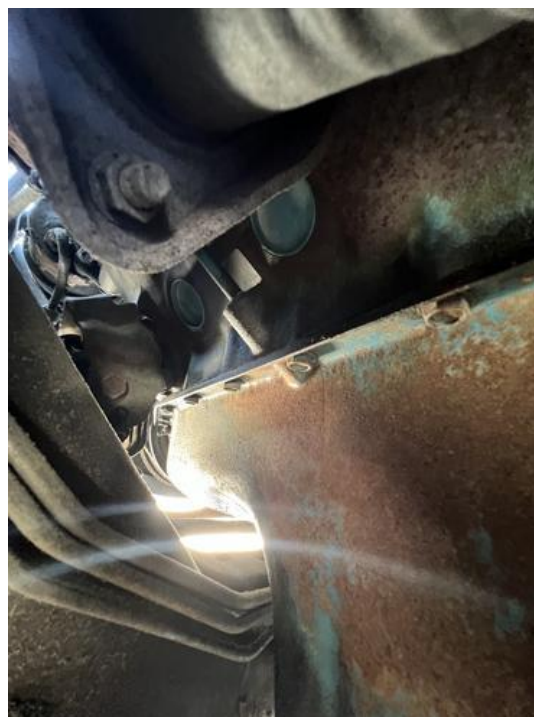
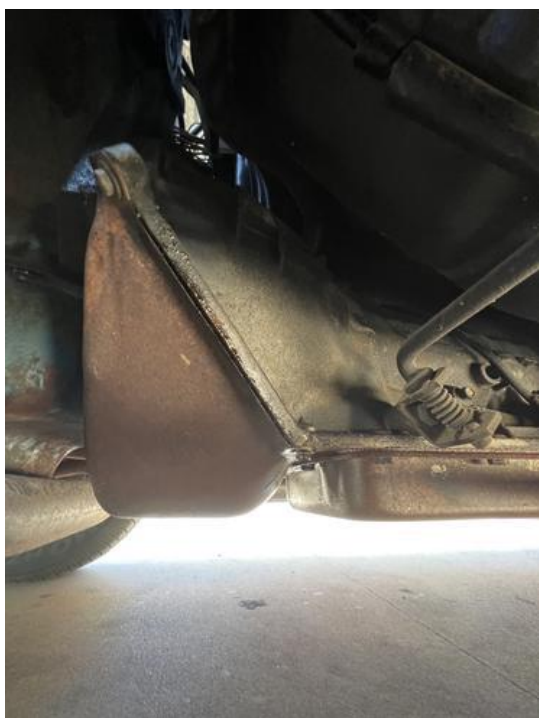
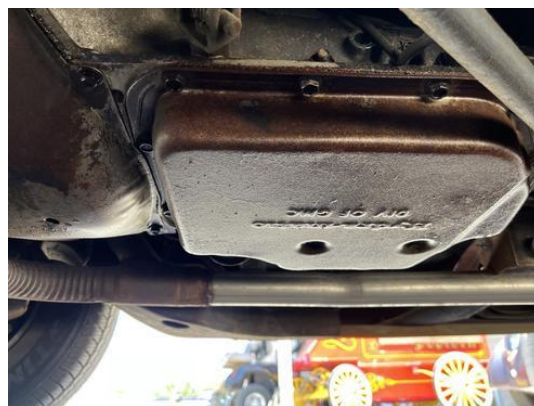
Engine clean internally, no gunk or sludge present. Proper signs of maintenance present. All external engine accessories in good working order. External drive belt and healthy condition. No external oil leaks or seepage from engine. Coolant make sure correct and coolant system functionality healthy.

Engine block test	Pass
Coolant mixture test	Pass
Air filter condition	Normal wear
Engine oil condition	Normal wear
Engine oil level	Healthy
Engine oil leaks	None
Coolant level	Healthy
Coolant hoses	Healthy
Radiator condition / function	Healthy
Engine operating temperature	Healthy
Cooling fan function	Healthy

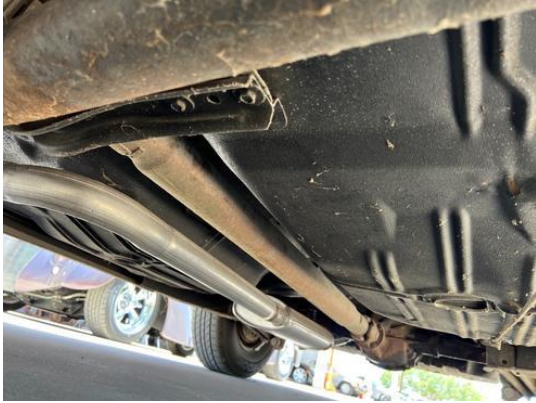
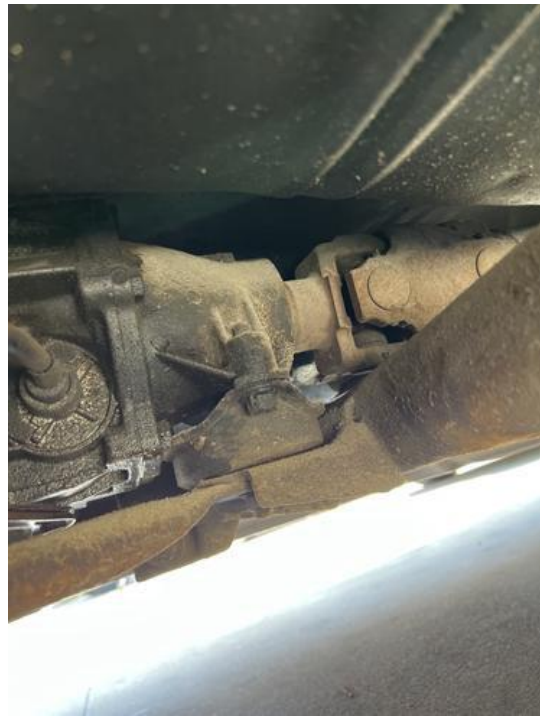
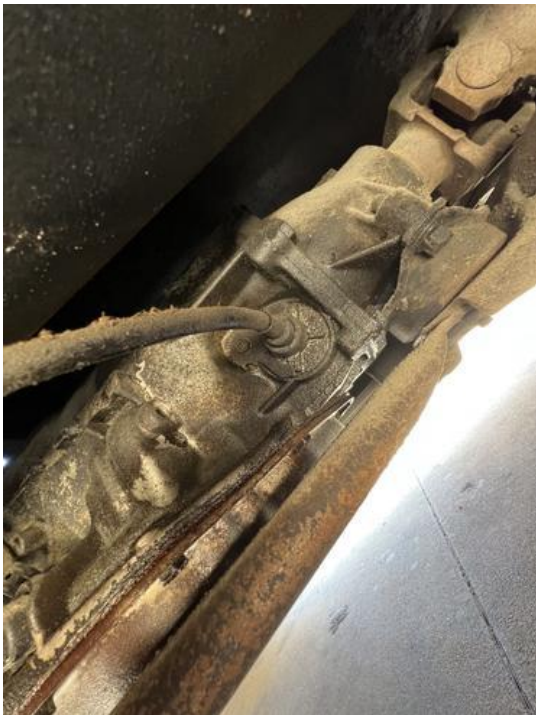
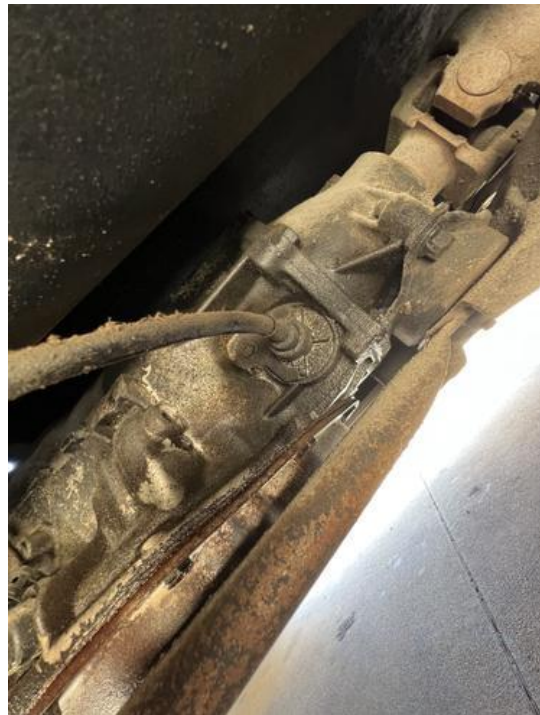
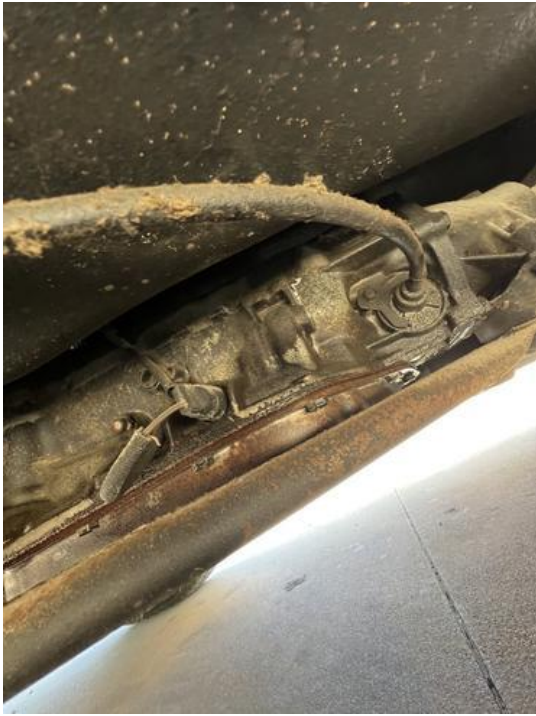
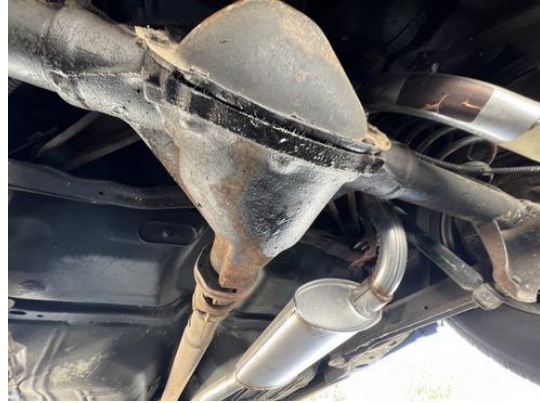
Transmission / Differentials	
Transmission fluid level	Healthy
Transmission fluid condition	Healthy
Transmission fluid leaks	None
<div>

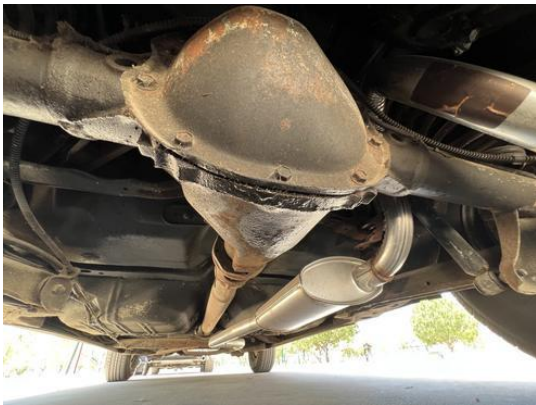
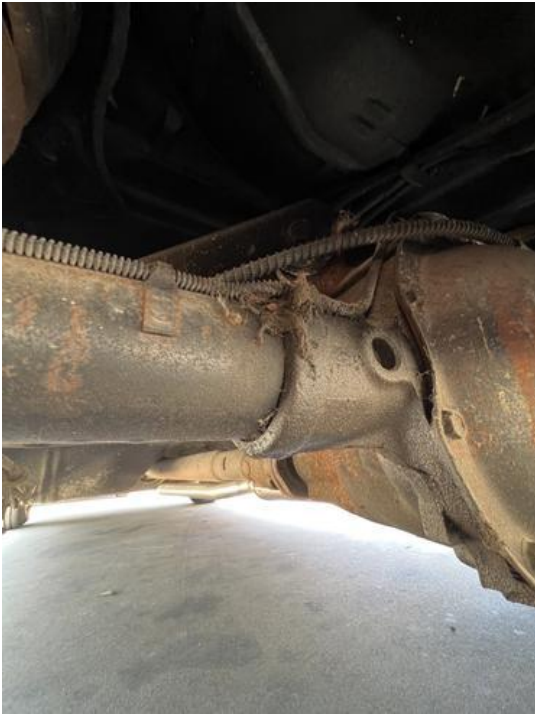
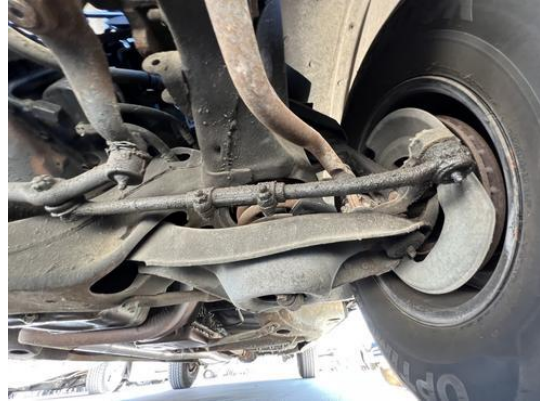
</div> <div> Photo 130 Photo 131 Photo 132 Photo 133 Photo 134 Photo 135 </div>	
Transmission cooler / lines	Healthy
Front differential condition	N/A
Center differential condition	N/A
Rear differential condition	Healthy
Residue noticed around rear differential cover, cover may need to be resealed in the future	
<div>

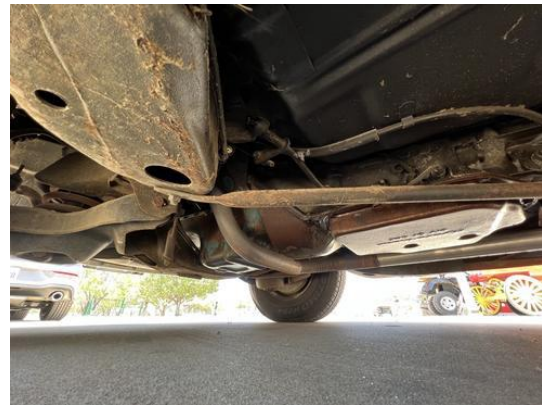
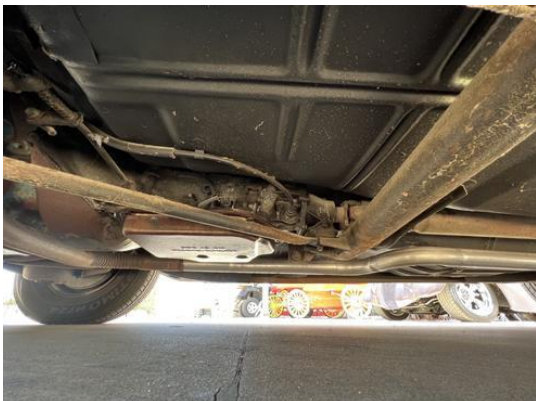
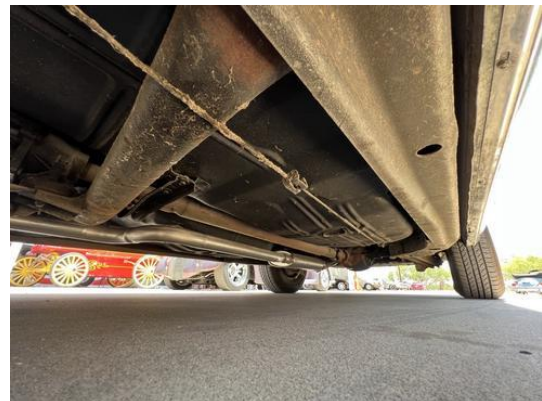
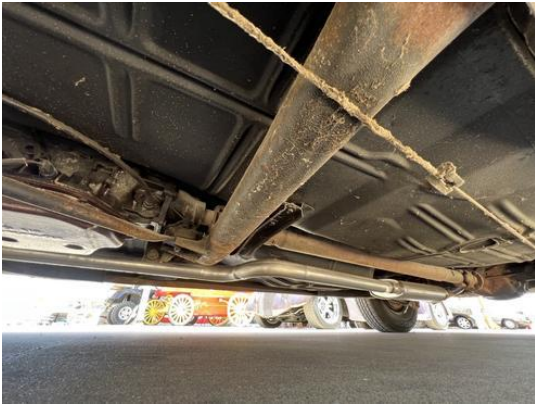
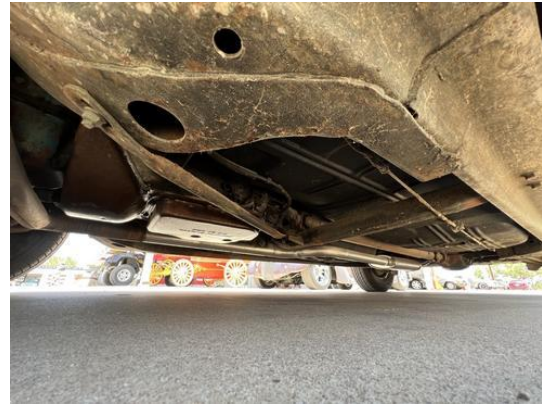
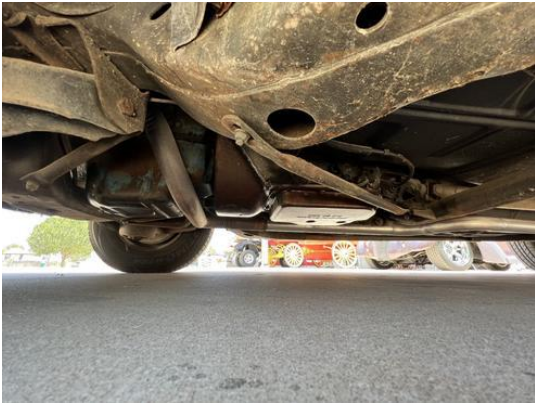
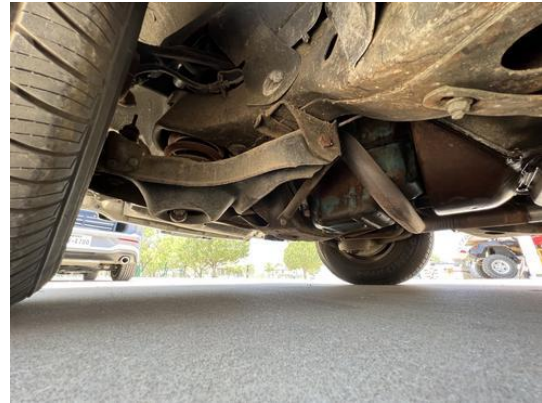
Abnormal rust / corrosion to metals
