## Peace of Mind Automotive Inspection Report.

Score	<b>100%</b>	Flagged items	<b>0</b>	Actions	<b>0</b>
<b>Site conducted</b>					Unanswered
<b>Customer name</b>					Jim
<b>Date / Time</b>					Sep 17th
<b>Payment method</b>					Invoice
<b>Inspection cost</b>					169
<b>Vehicle Year / Make / Model / Color</b>					2013 Jeep Wrangler red
<b>VIN</b>					72473 last 5
<b>license plate</b>					Dealer
<b>Mileage</b>					98343
<b>Color</b>					Red

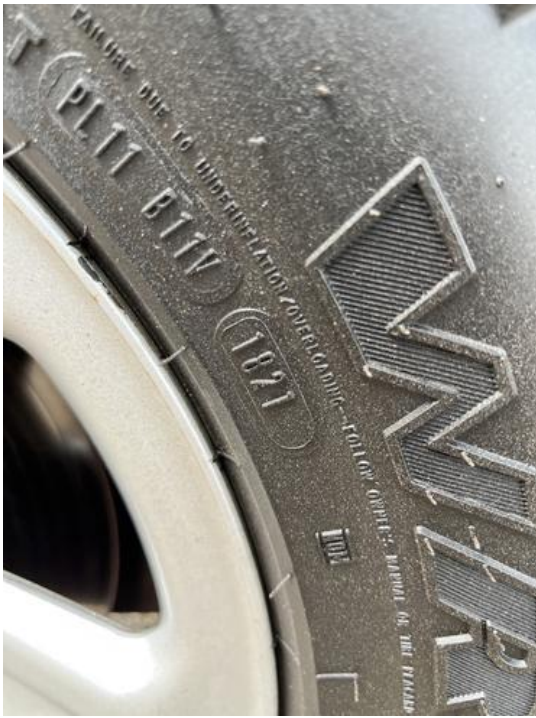
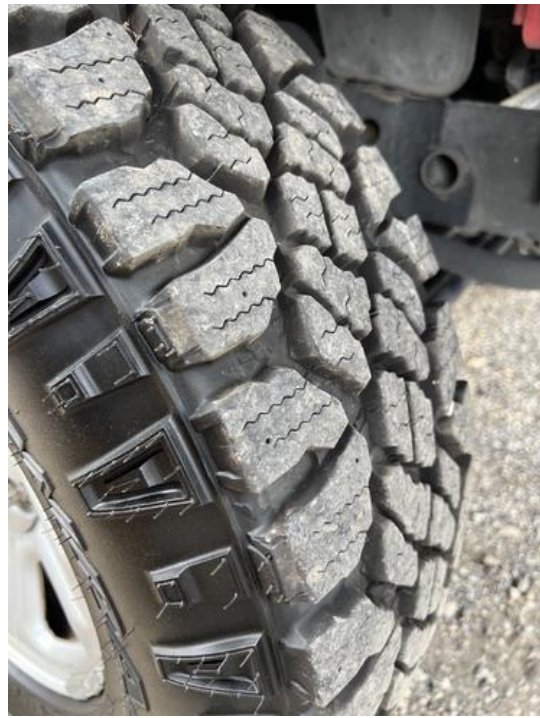
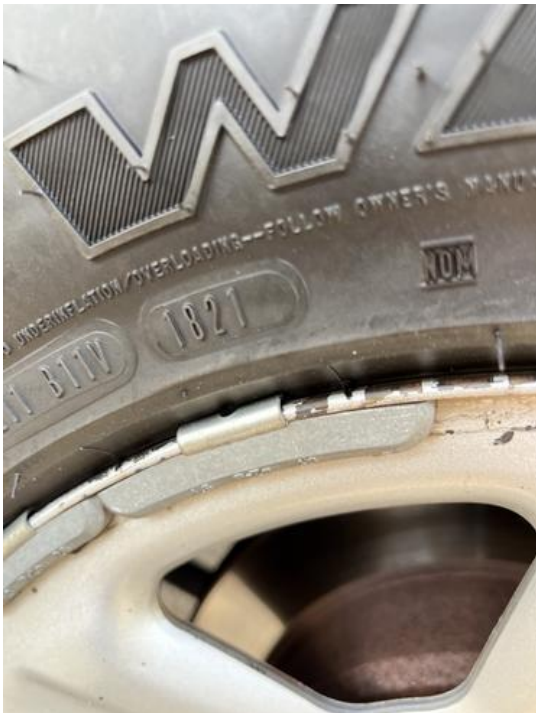
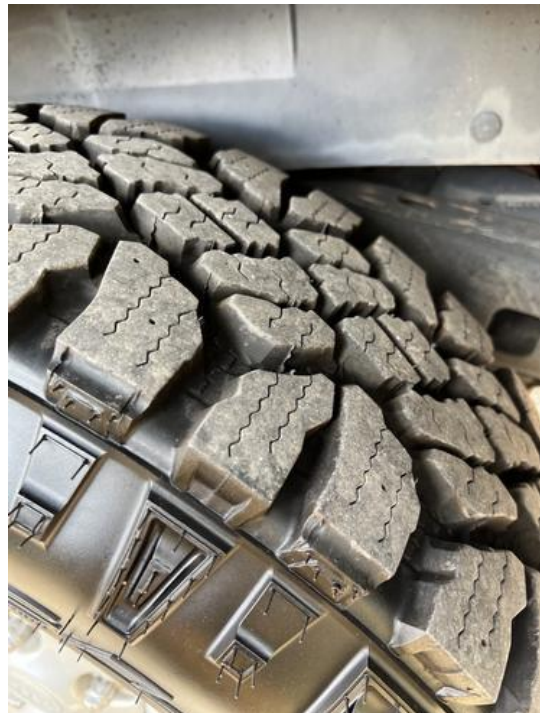
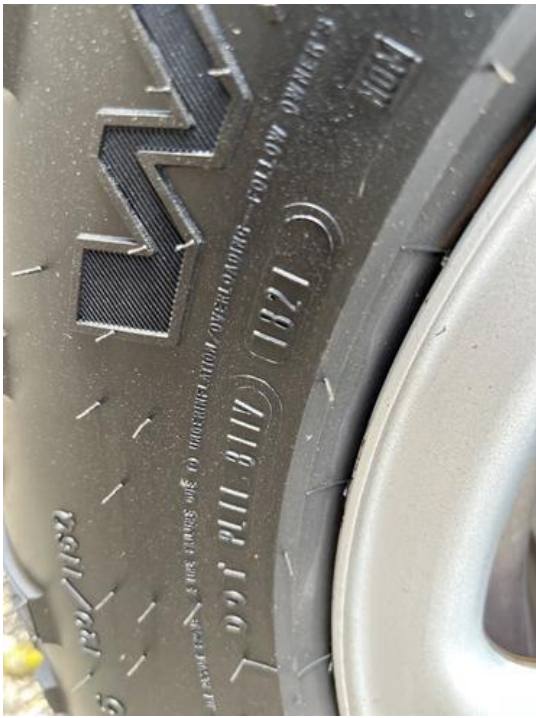
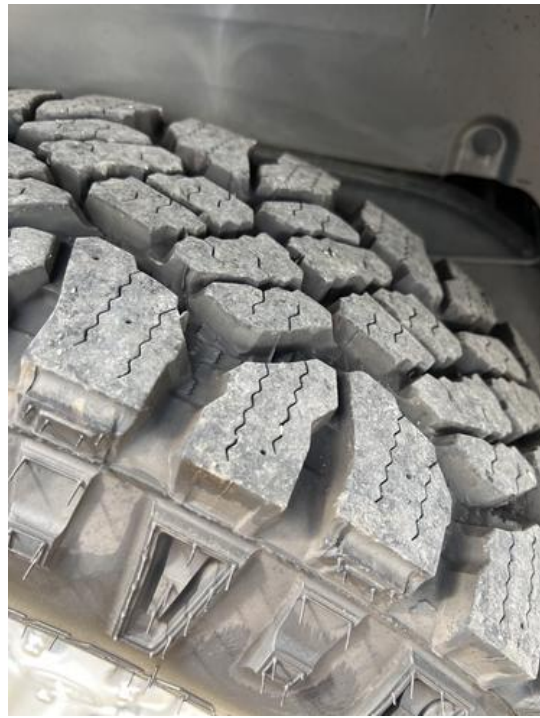
Tires are matching on all four corners with over 85% tread life remaining. No abnormal wear present whatsoever

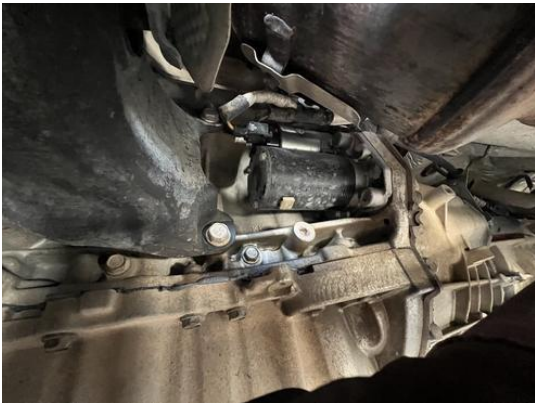
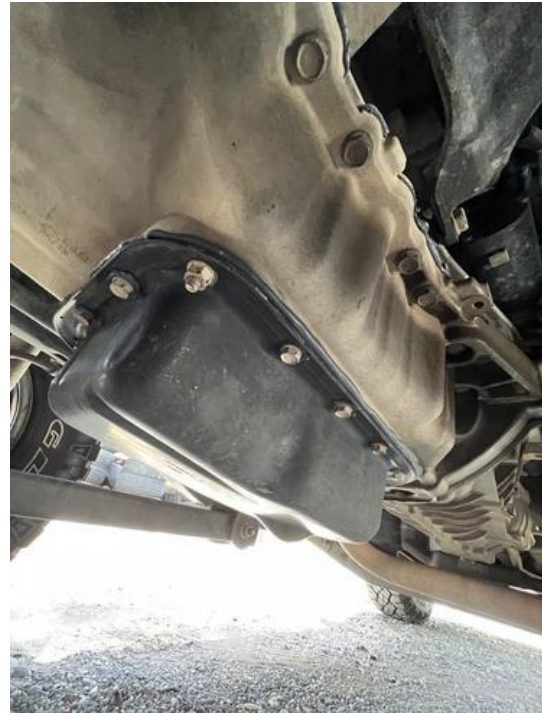
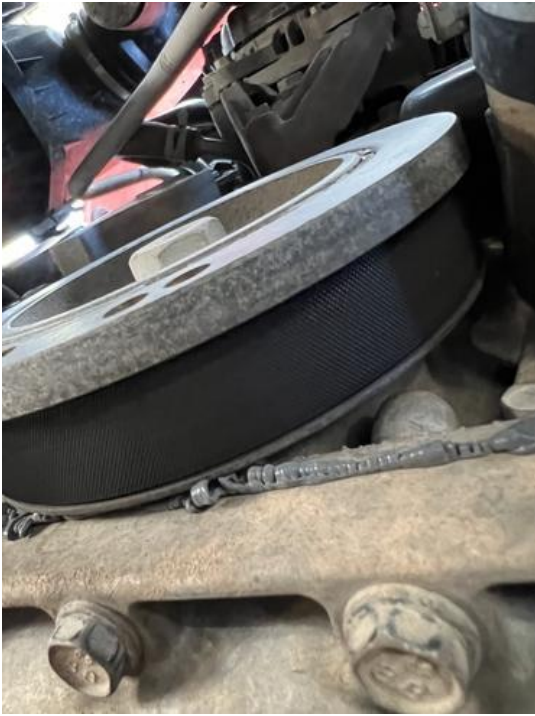
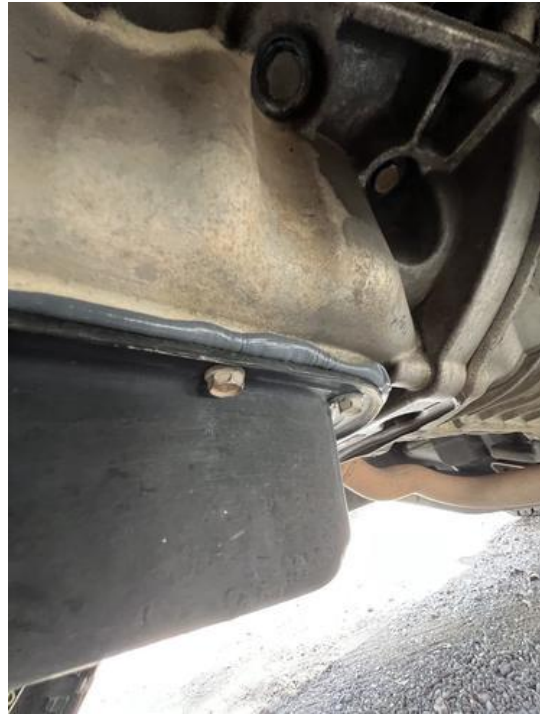
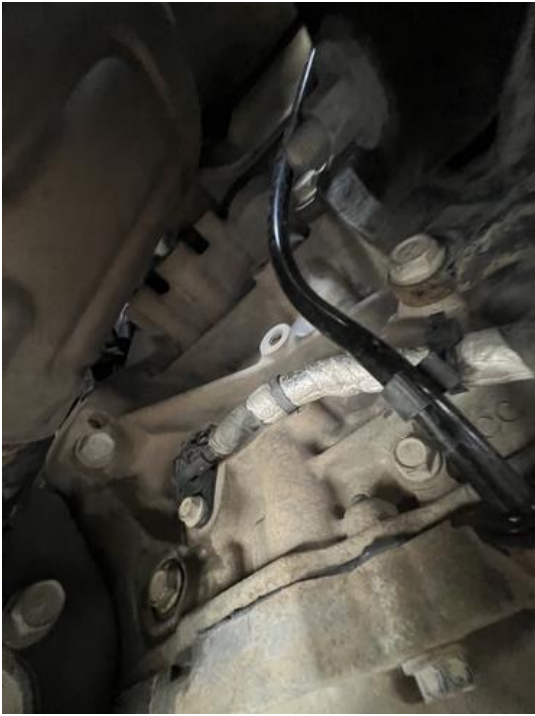
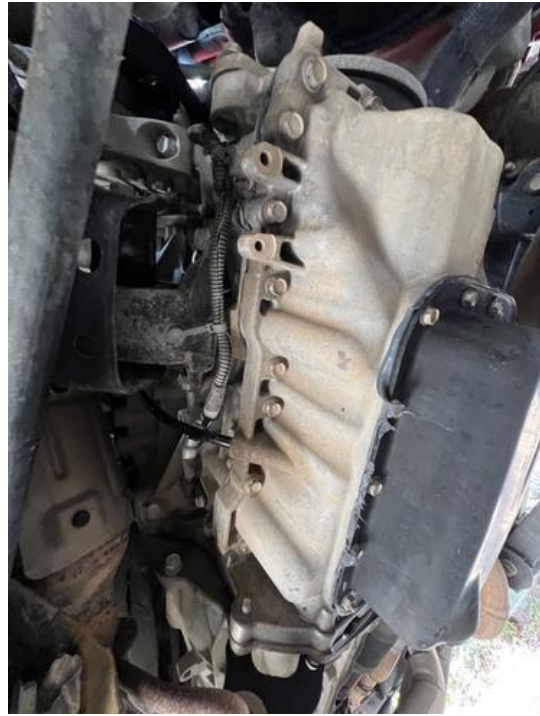
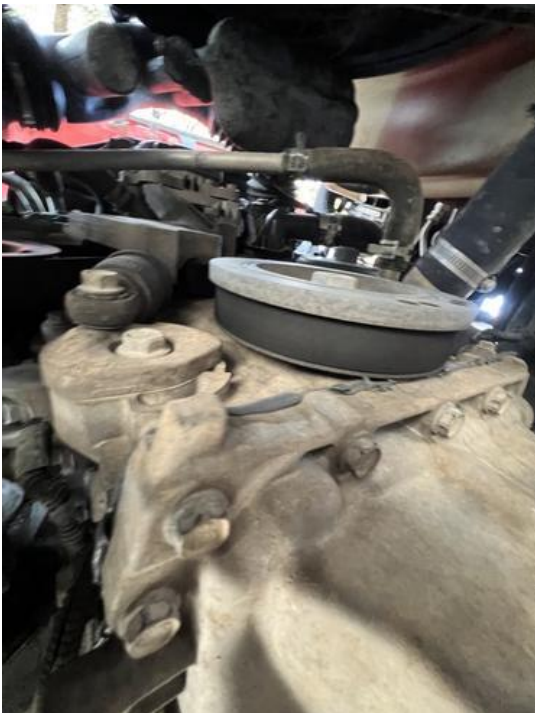
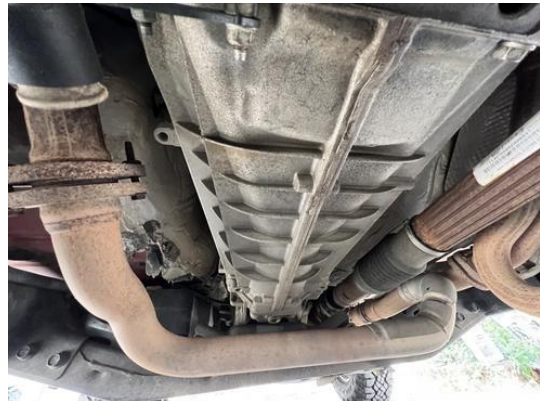
Engine clean internally, no gunk or sludge present. Proper signs of maintenance present. All external engine accessories in good working order. External drive belt in healthy condition. Coolant mixture correct and coolant system functionality healthy. No external oil leaks or seepage from anywhere on the engine, noticed previous replacement of both primary and secondary oil pan gasket. Currently no mechanical issues present in relation to the engine.

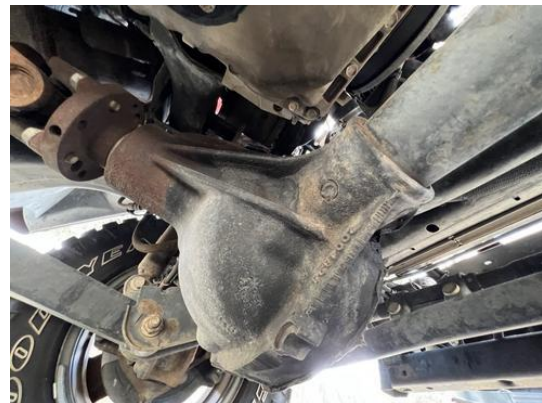
Photo 85

No transmission fluid leak out. No fluid leak out from the center differential, front differential or rear differential casing.

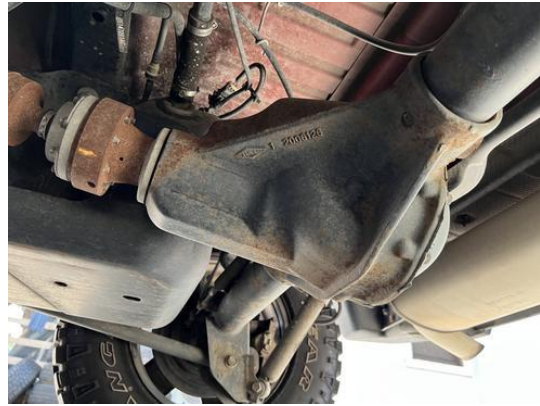
Photo 91

**Center differential condition**

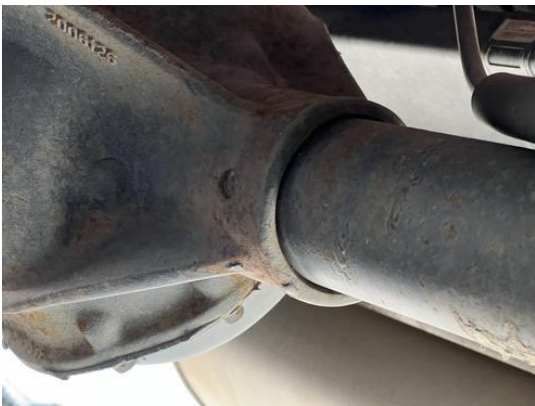
Photo 92

**Rear differential condition**

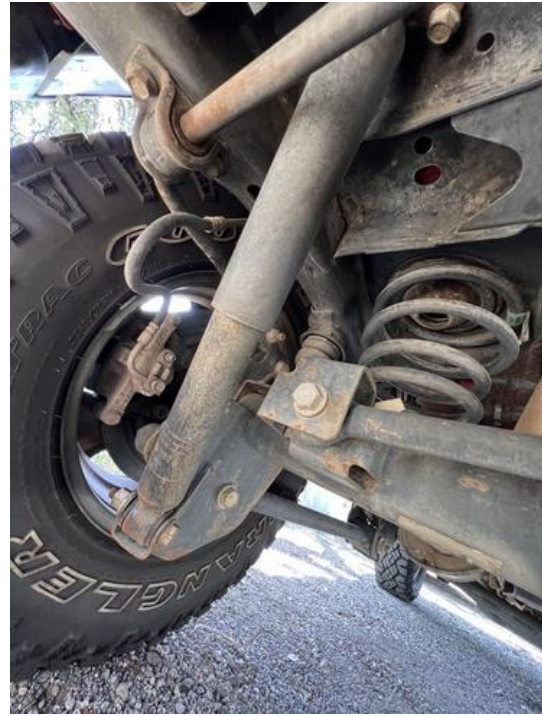
Photo 101

Normal wear/fatigue notice to suspension. No suspension components are blown out and do for replacement however nothing is recognized as recently replaced either. No excessive surface rust on the expose metal. All rubber in relation to mounts joints and bushings rich with texture.

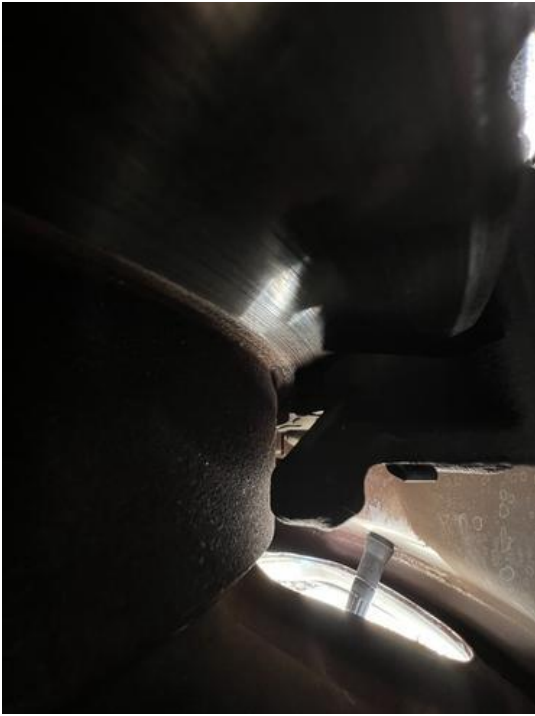
Photo 108

<p>Photo 108</p>	
Rear brake pad life remaining	50-75% remaining
